# Manhole Inspection Summary

Manhole # S27A\_\_032MH

Insp Date: **12/4/07 11:08 AM**

**Location** Address: **801 GEORGE ST**

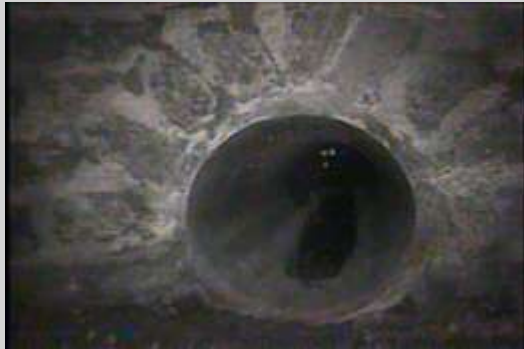
12 O'Clock Outflow

8 in. Circular Gravity Sewer  
Pipe Out @ 12 O'Clock

Infiltration: **None** Pipe Seal Cond: **Sound**
